4. TITLE (and Subtitle) BALD EAGLE CREEK AND LITTLE JUNIATA RIVER CHANNEL IMPROVEMENT PROJECT; Hydraulic Model Investigation	5. TYPE OF REPORT & PERIOD COVERED Final report, Dec 78-Mar 79

7. AUTHOR(s) John F. George	8. CONTRACT OR GRANT NUMBER(s)	
9. PERFORMING ORGANIZATION NAME AND ADDRESS U. S. Army Engineer Waterways Experiment Station Hydraulics Laboratory P. O. Box 631, Vicksburg, Miss. 39180	10. PROGRAM ELEMENT, PROJECT, TASK AREA & WORK UNIT NUMBERS

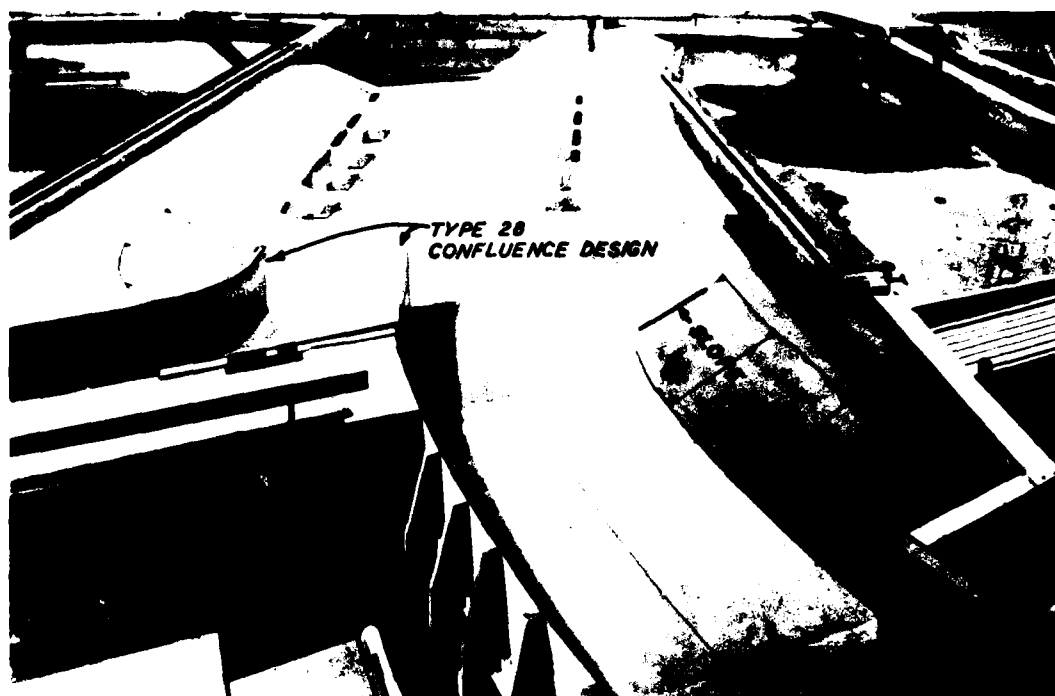
Figure 3. Looking downstream at the type 28 confluence design and slope modification on the right bank of the Little Juniata River

24. Tests were conducted in the Little Juniata River with a modification extending the 1V-on-2H slope upstream to sta 137+19.39 (Figure 3), to determine if this would have any effect on flow conditions in the Little Juniata River. Details of the slope modification with the type 28 confluence design are provided in Plate 18. Test results indicated that the modification had little effect on the general flow conditions throughout the reach of the Little Juniata River reproduced in the model (Photo 26). Velocities measured in this vicinity are shown in Plates 19 and 20.

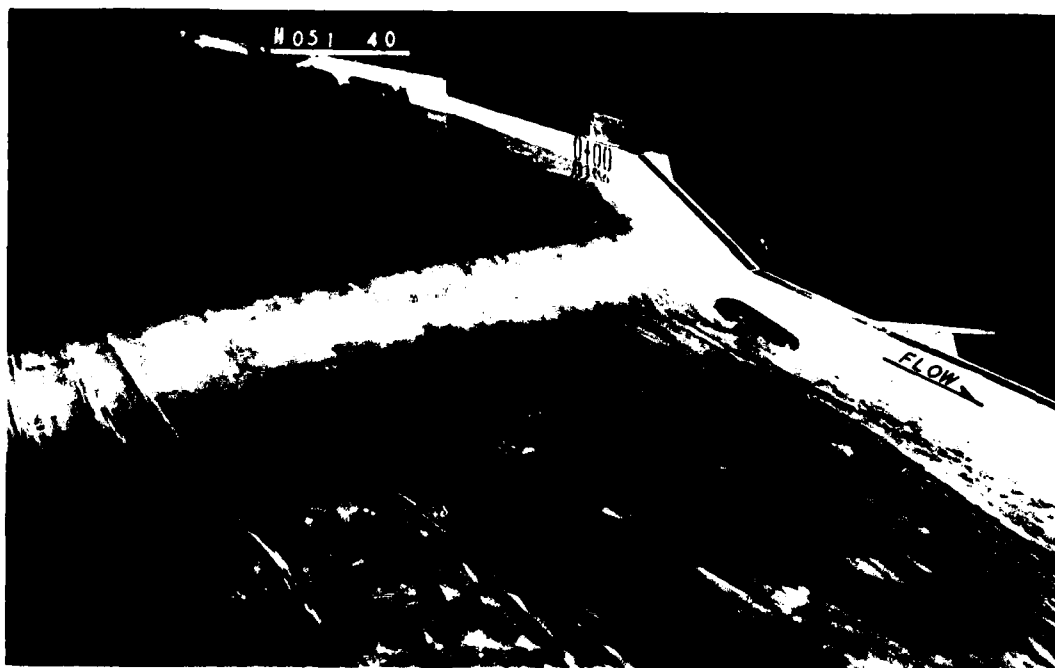
Photo 6. Looking upstream at flow conditions along left side of Westvaco Dam with the type 2 slope modification installed upstream of the dam; discharge 13,400 cfs

11. Several modifications to the existing topography on the left side (looking downstream) upstream of Westvaco Dam were tested in an effort to reduce the buildup of flow that occurred along the left abutment of the dam. A 1V-on-2.5H tapering slope (type 2) shown in Photo 5, reduced the buildup of flow along the left abutment considerably, thus decreasing the height of cross waves immediately downstream (Photo 6).

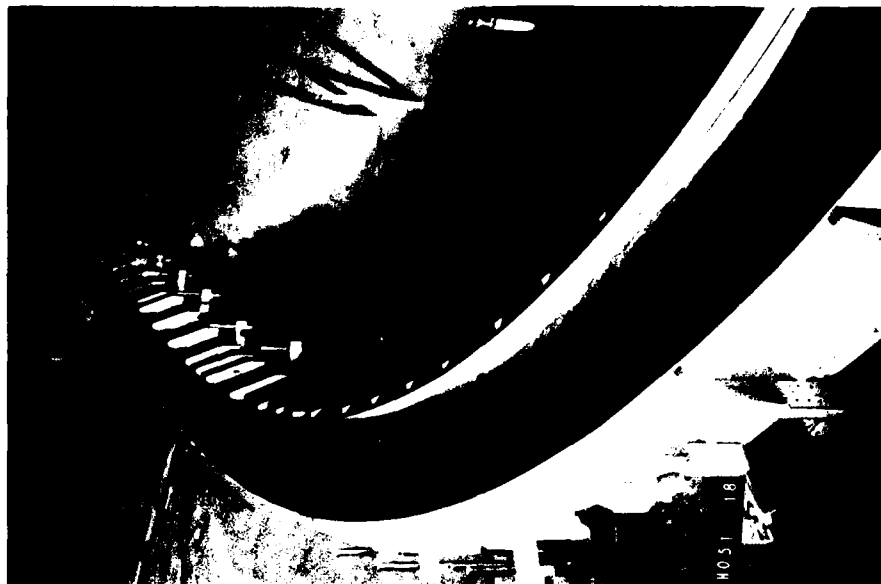
a. Dry bed

b. Discharge 11,000 cfs

c. Discharge 13,400 cfs

Photo 12. Looking downstream in Bald Eagle Creek between sta 52+25 and 42+00. Black lines inside of channel walls represent proposed wall heights

17. Flow conditions in the Bald Eagle Creek high-velocity channel were generally satisfactory for the full range of discharges tested, including the design discharge of 13,400 cfs (Photos 11-15). The wall heights were adequate to contain design flood conditions, including the surface waves present in curves 6 and 7.

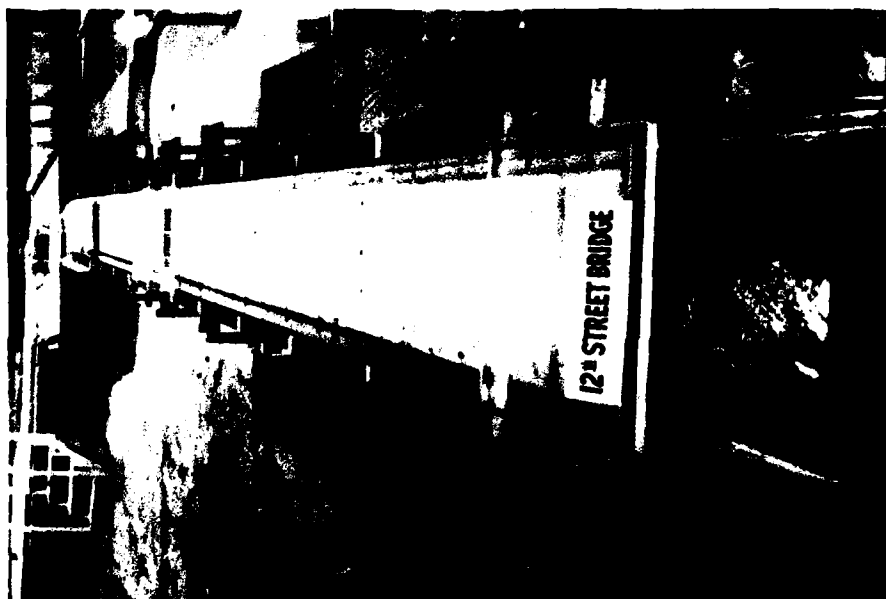
a. Dry bed

b. Discharge 11,000 cfs

c. Discharge 13,400 cfs

Photo 15. Looking downstream in Bald Eagle Creek between sta 23+00 and 12+00. Black lines inside of channel walls represent proposed wall heights

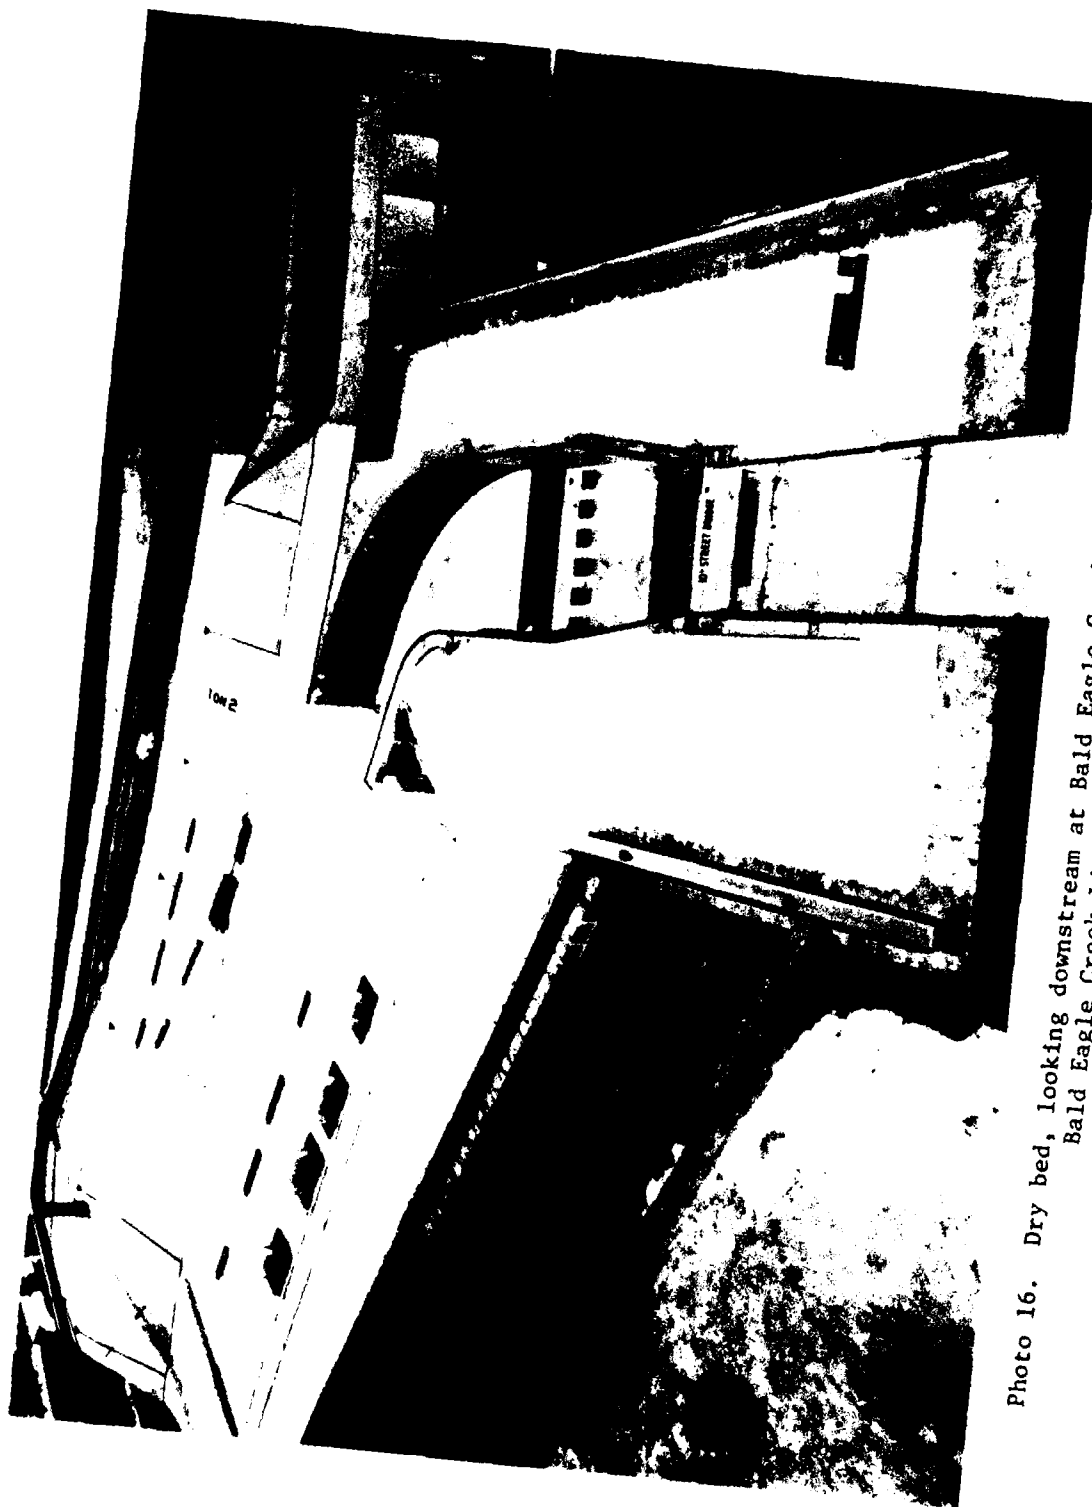
Photo 16. Dry bed, looking downstream at Bald Eagle Creek stilling basin and the  
Bald Eagle Creek-Little Juniata River confluence

Creek stilling basin and at the Bald Eagle Creek-Little Juniata River confluence (Photo 16, Plate 13) for both flood conditions. During a maximum discharge of 13,400 cfs in Bald Eagle Creek with no flow in the Little Juniata River, fairly good stilling basin action was obtained (Photo 17a), although high exit velocities were measured at the confluence. The curved channel downstream of the stilling basin caused unequal flow distribution in the Bald Eagle exit channel and directed the majority of flow along the left side of the Little Juniata River (Photo 18a). With discharges of 11,000 cfs in Bald Eagle Creek and 29,300 cfs (design discharge) in the Little Juniata River, dissipation of energy in the stilling basin was unsatisfactory due to the effects of high tailwater which caused flow in Bald Eagle Creek to ride over the basin. This resulted in little dissipation of energy before flow entered the Little Juniata River (Photo 17b). Also with design flood conditions in the Little Juniata River, the river flow forced the smaller flow from Bald Eagle Creek against the left bank slope downstream from the confluence (Photo 18b). Velocities measured in this vicinity are shown in Plates 14 and 15. Tailwater elevations used with these tests are shown in Plate 16.

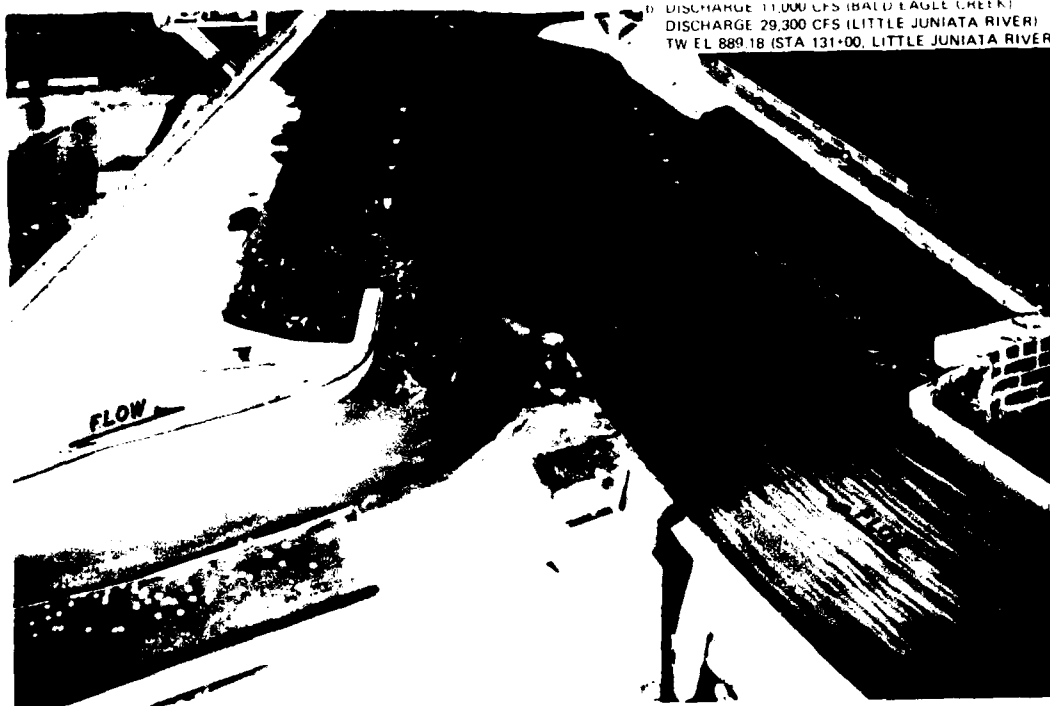
DISCHARGE 13,400 CFS (BALD EAGLE CREEK)  
DISCHARGE 0 CFS (LITTLE JUNIATA RIVER)  
TW EL 877.78 (STA 131+00, LITTLE JUNIATA RIVER)

DISCHARGE 11,000 CFS (BALD EAGLE CREEK)  
DISCHARGE 29,300 CFS (LITTLE JUNIATA RIVER)  
TW EL 889.18 (STA 131+00, LITTLE JUNIATA RIVER)

Photo 19. Looking downstream at flow conditions at the confluence with confluence wall ending at sta 9+73.18. Confetti illustrates surface flow patterns. Exposure time 5 sec (prototype)

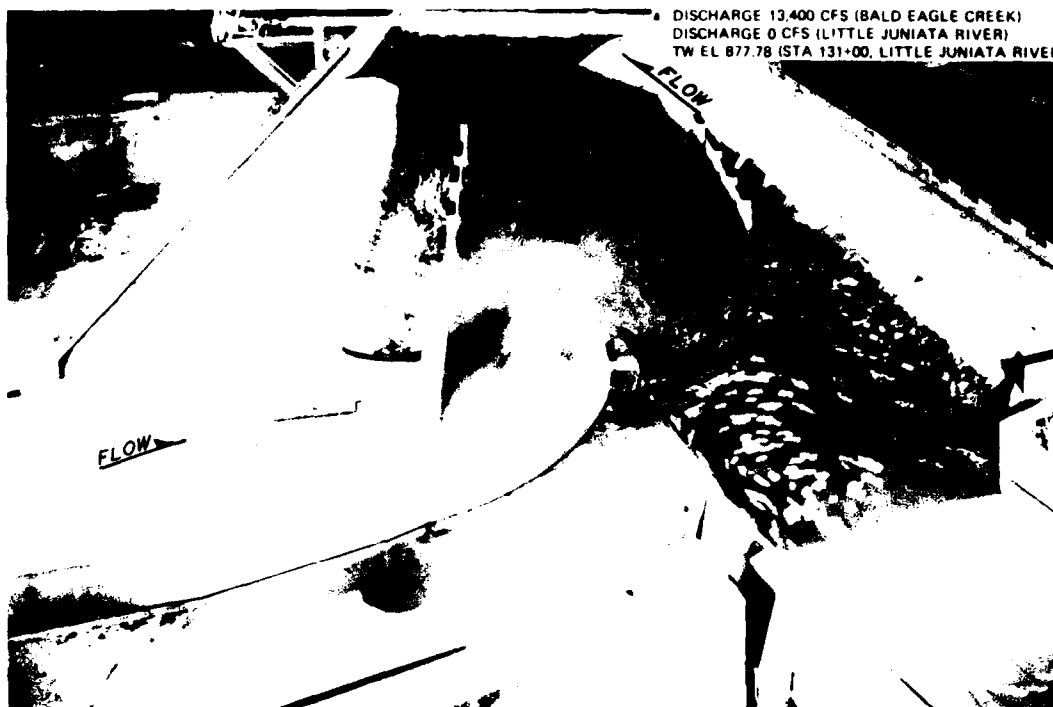
Photo 20. Looking downstream at flow conditions at the confluence with  
 the confluence wall ending at sta 9+63.18. Confetti illustrates surface  
 flow pattern. Exposure time 5 sec (prototype)

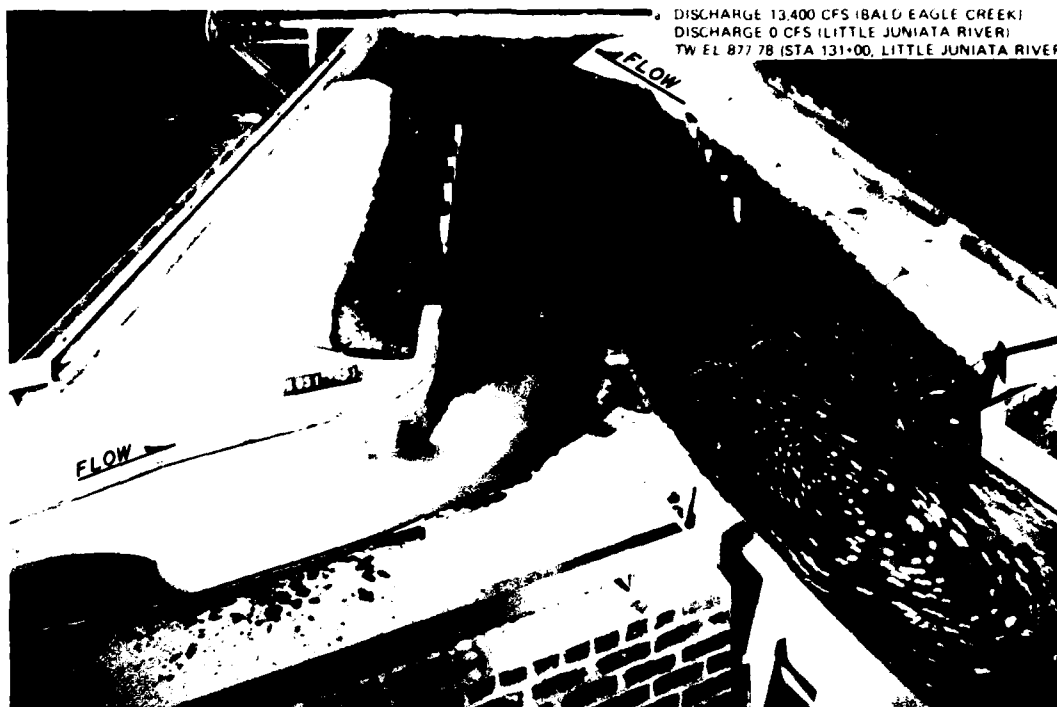
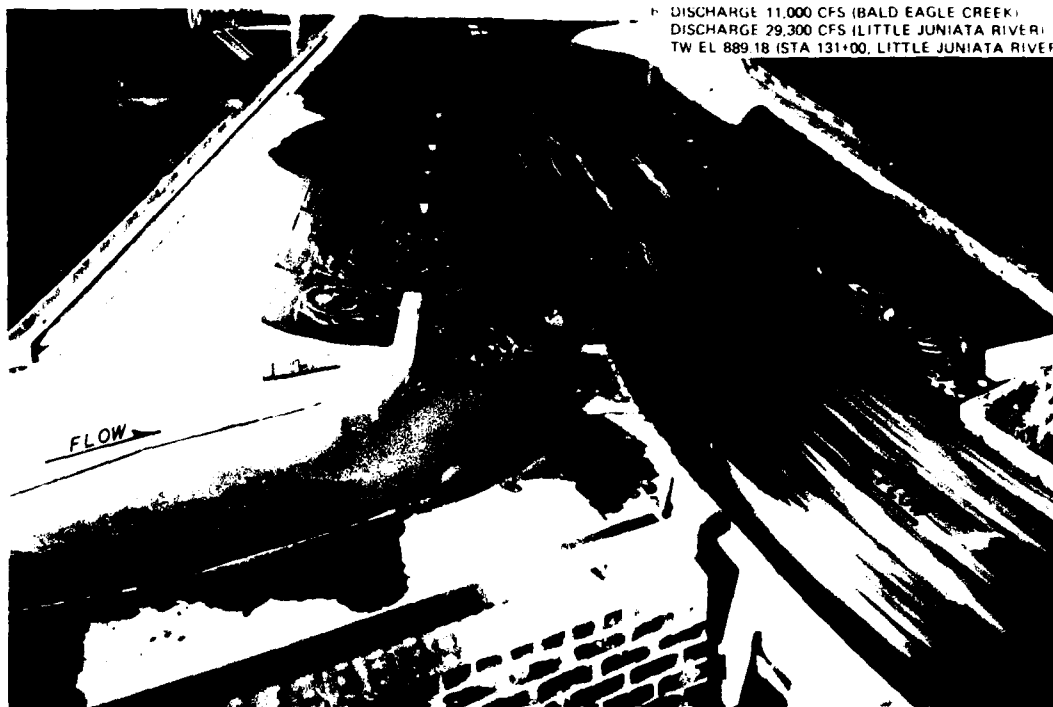
DISCHARGE 13,400 CFS (BALD EAGLE CREEK)  
DISCHARGE 0 CFS (LITTLE JUNIATA RIVER)  
TW EL 877.78 (STA 131+00, LITTLE JUNIATA RIVER)

DISCHARGE 11,000 CFS (BALD EAGLE CREEK)  
DISCHARGE 29,300 CFS (LITTLE JUNIATA RIVER)  
TW EL 889.18 (STA 131+00, LITTLE JUNIATA RIVER)

Photo 21. Looking downstream at flow conditions at the confluence with the confluence wall ending at sta 9+58.18. Confetti illustrates surface flow patterns. Exposure time 5 sec (prototype)

Bald Eagle Creek against the left slope downstream of the confluence. Flow conditions with this modification are shown in Photo 21.

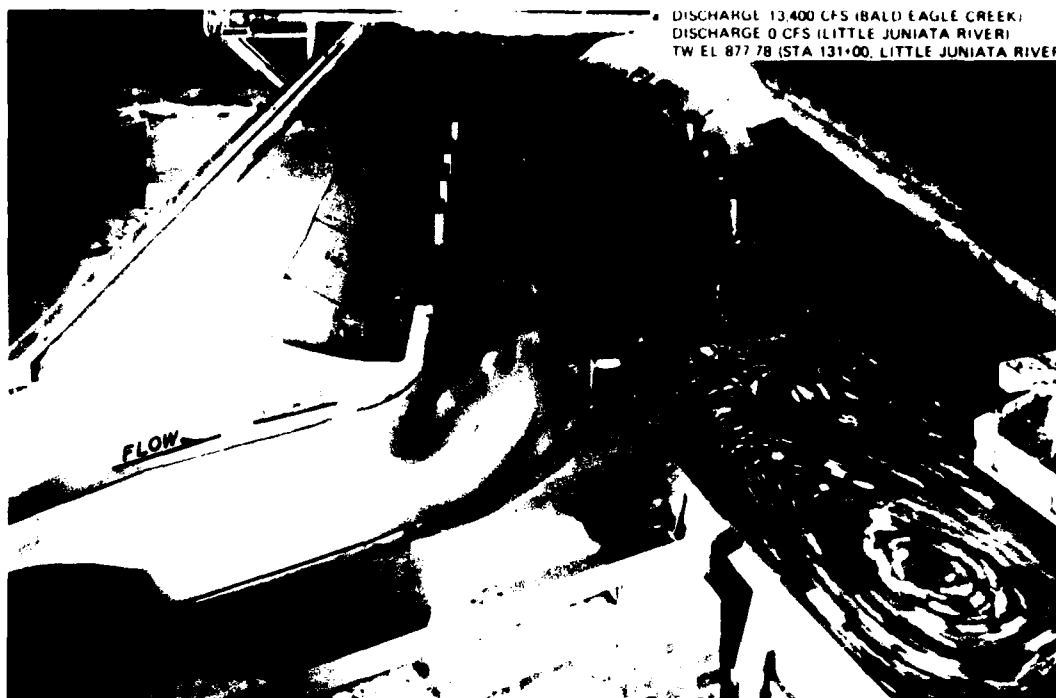
Photo 23. Looking downstream at flow conditions at the confluence with the confluence wall ending at sta 9+58.18, end sill elevation 864.60, and two flow control vanes in the exit channel. Confetti illustrates surface flow patterns. Time exposure 5 sec (prototype)

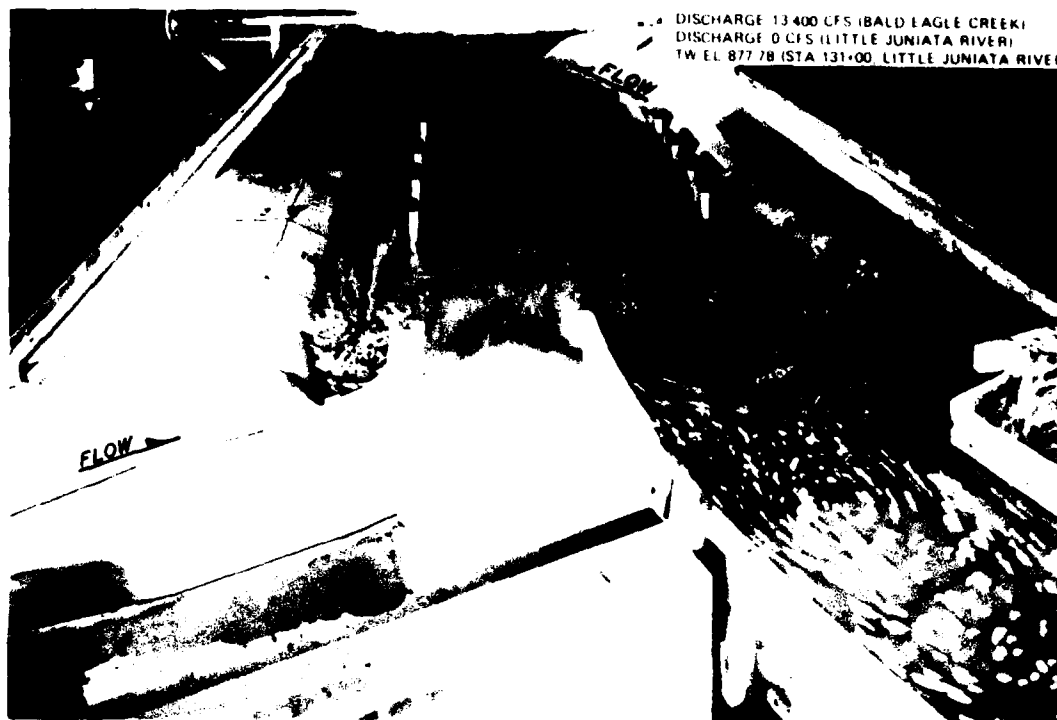
Photo 24. Looking downstream at flow conditions at the confluence with the type 28 confluence design installed. Confetti illustrates surface flow patterns. Time exposure 5 sec (prototype)

Bald Eagle Creek, significant improvement in flow conditions at the confluence (Photo 24) was observed relative to the original confluence curvature previously tested. The original stilling basin design was in place during these tests. Very little change was observed in the performance of the stilling basin with the type 28 confluence design, as shown in Photo 25.

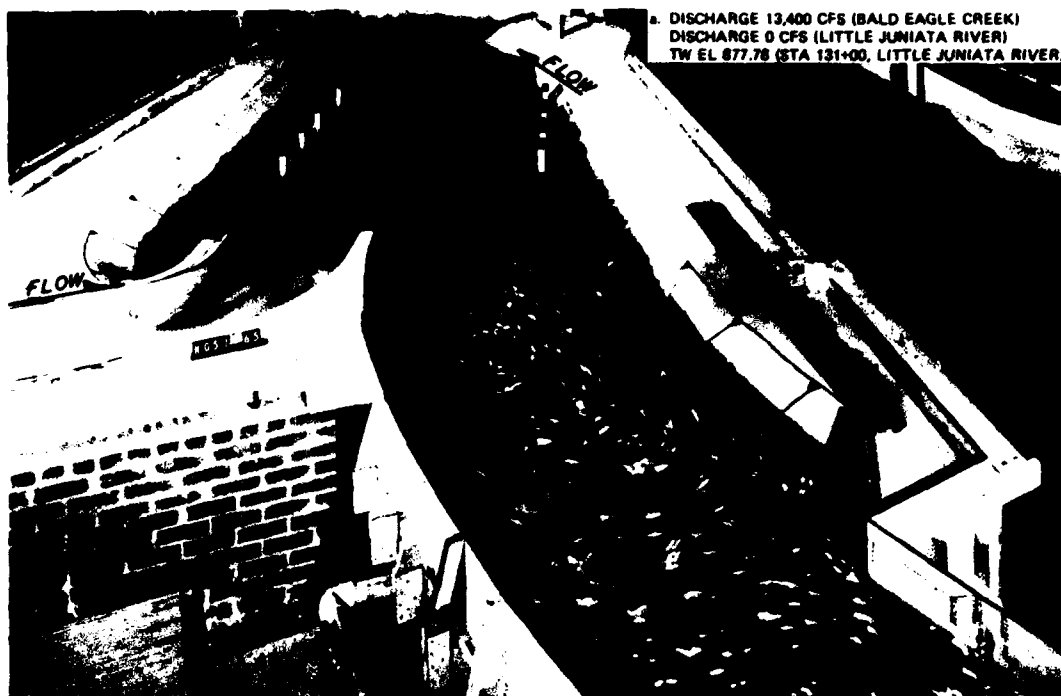
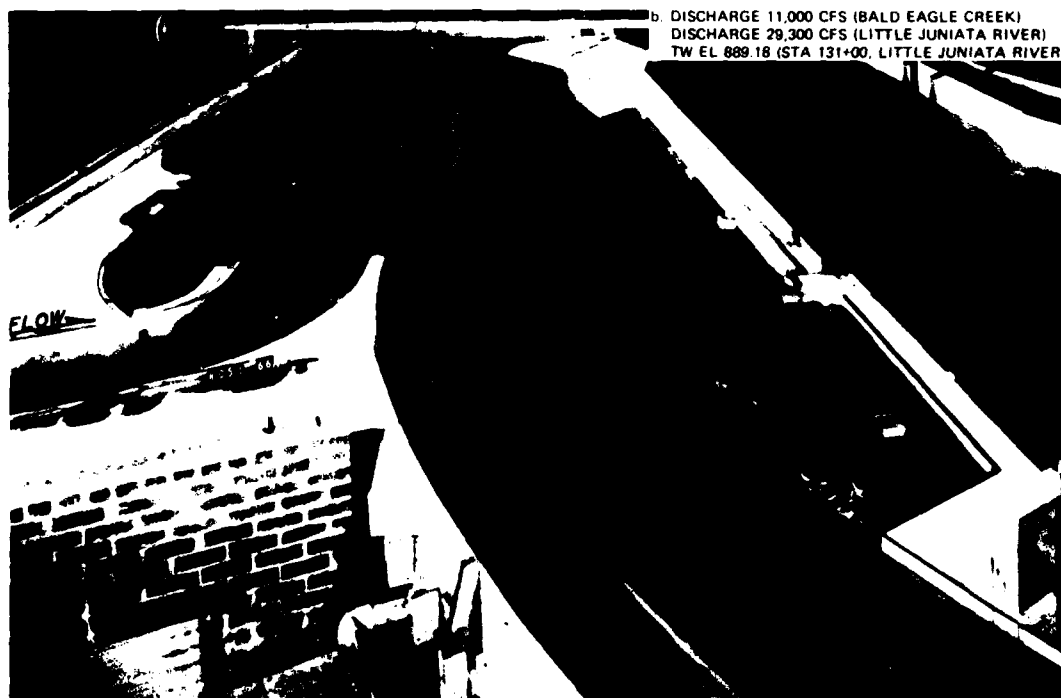
Photo 26. Looking downstream at flow conditions at the confluence with the type 28 confluence design and slope modification on the Little River between sta 135+35 and 137+19.39. Confetti illustrates surface flow patterns. Time exposure 5 sec (prototype)

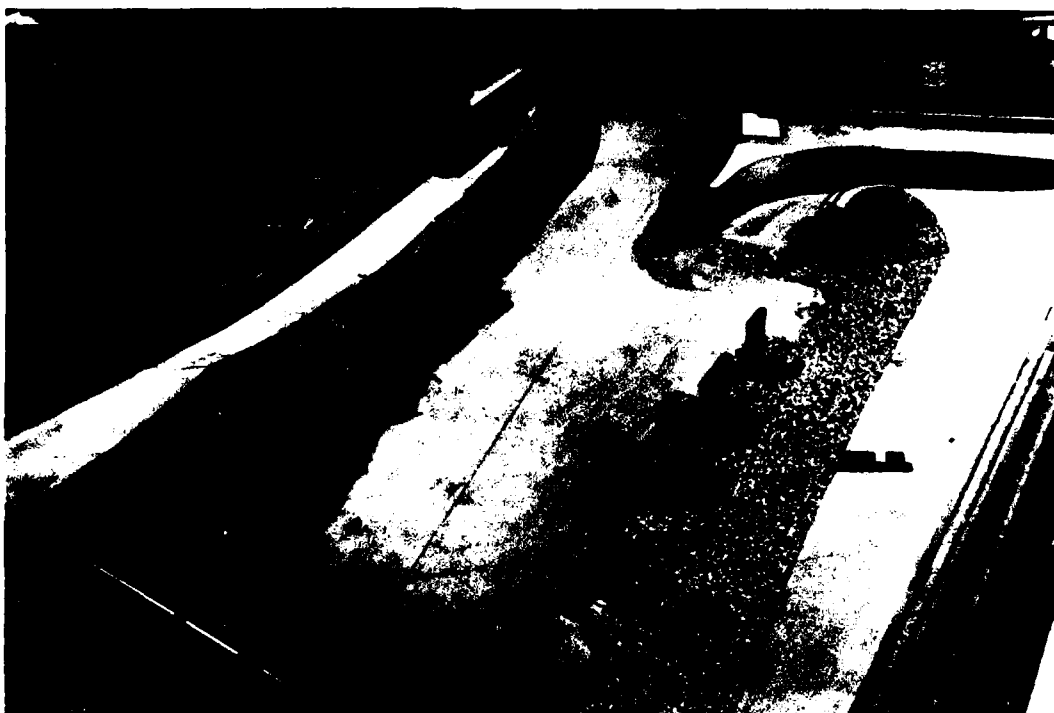
Photo 27. Looking upstream at the type 1 riprap plan

26. The type 1 plan consisted of riprap with an average diameter ( $D_{50}$ ) of 16 in. and a blanket thickness of 24 in. on the side slopes from sta 137+19.39 to 131+00 (Photo 27). Tests were conducted with flow conditions resulting from numerous combinations of discharges ranging from 2,500 to 13,400 cfs in Bald Eagle Creek and from 2,500 to 29,300 cfs in the Little Juniata River. These tests were conducted for a minimum of 5 hr (prototype) for each flow condition and for 15 hr (prototype) each with design flow conditions in Bald Eagle Creek and in the Little Juniata River. No failure was observed during these tests.

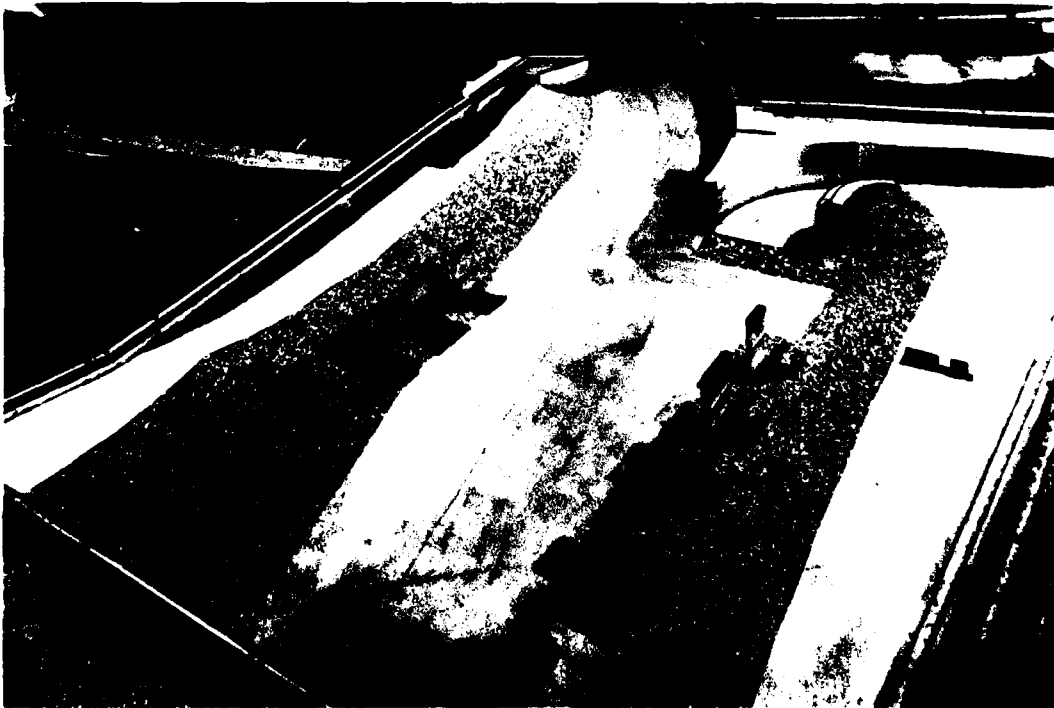
Photo 28. Looking upstream at the type 2 riprap plan

27. The size of the riprap was reduced to an average diameter ( $D_{50}$ ) of 12 in. with a blanket thickness of 18 in. (type 2, Photo 28). Failure occurred along the right slope after a 10-hr test with a discharge

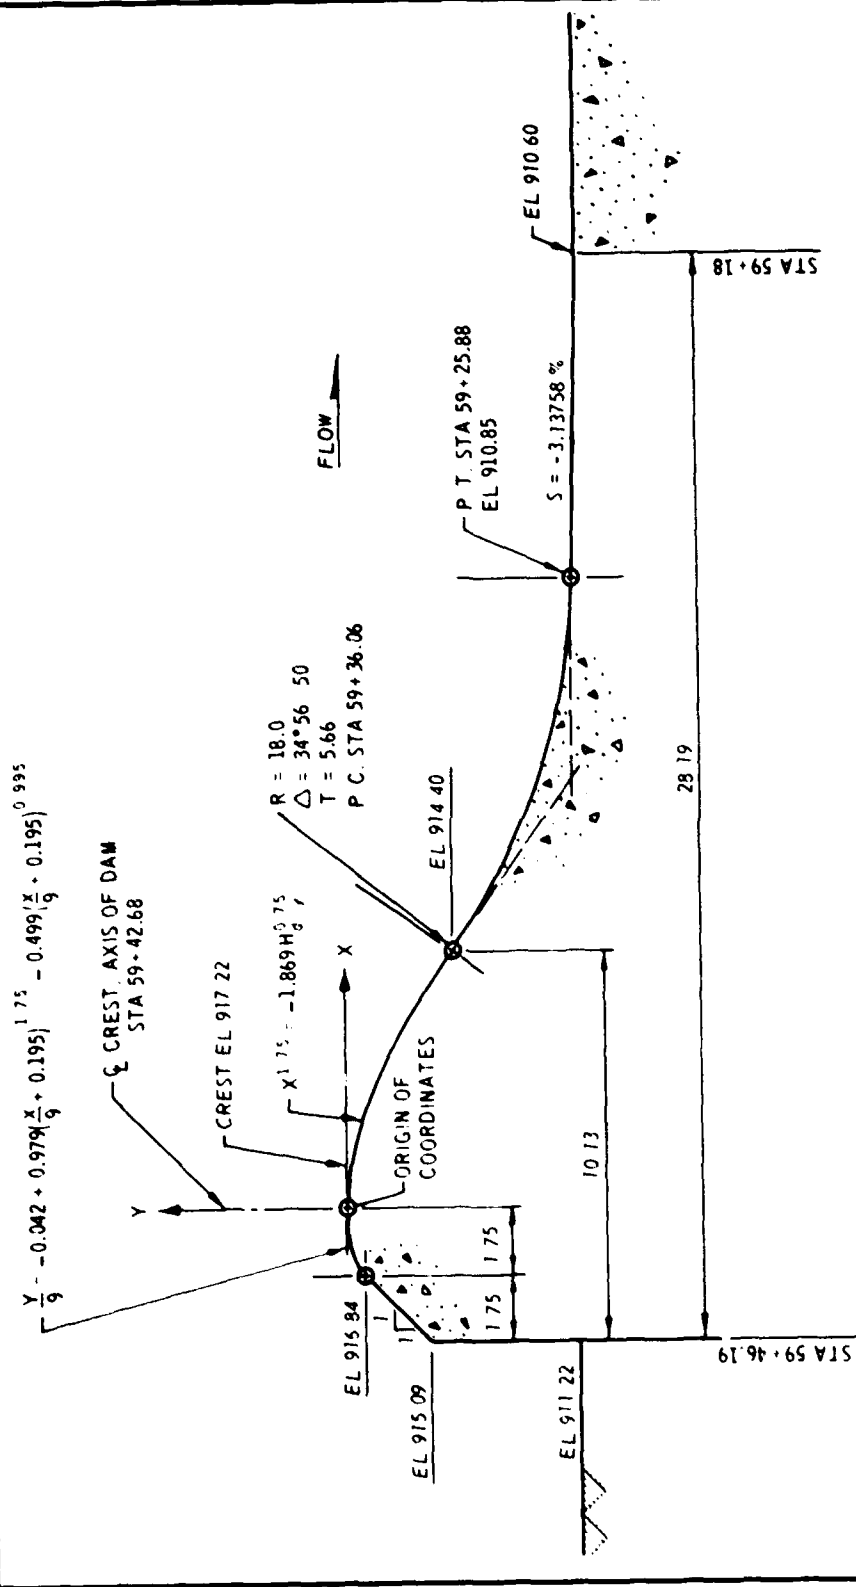
WESTVACO DAM  
WEIR GEOMETRY

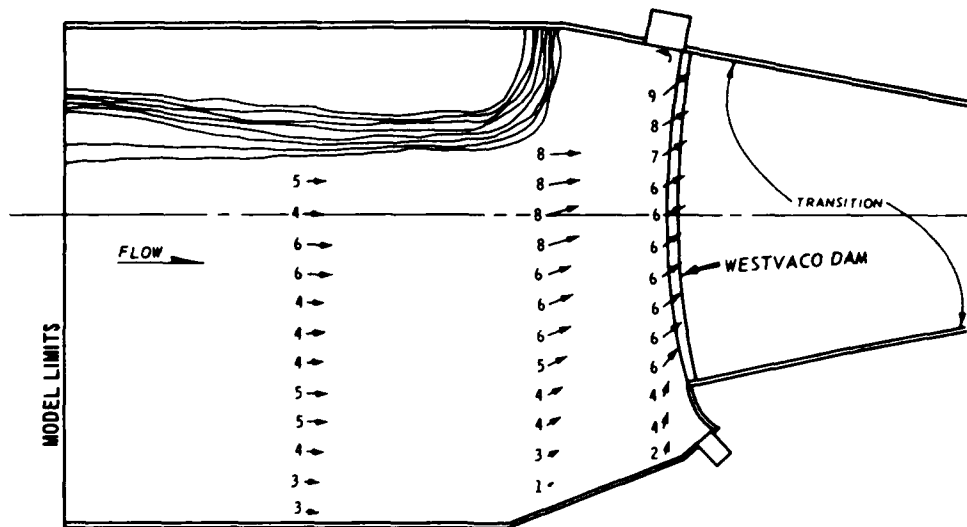
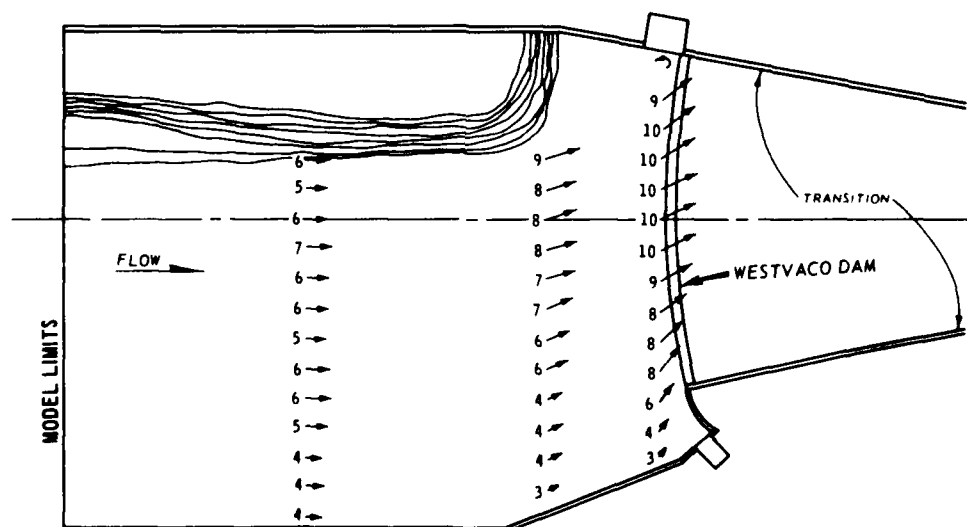
**PLAN**  
(1 FT ABOVE CHANNEL INVERT)

**PLAN**  
(7 FT ABOVE CHANNEL INVERT)

**MAXIMUM VELOCITIES  
UPSTREAM OF WESTVACO DAM  
TYPE 1 (ORIGINAL) DESIGN  
DISCHARGE 13,400 CFS**

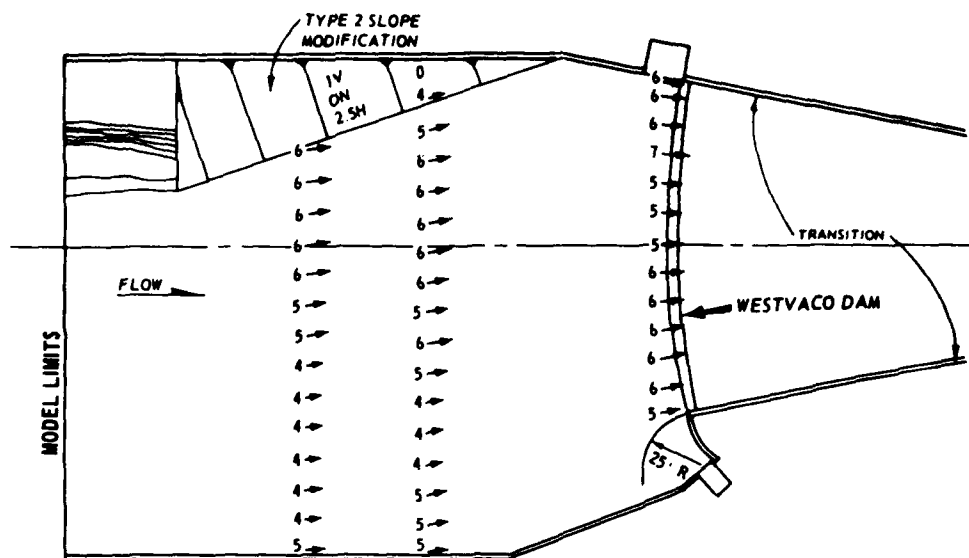
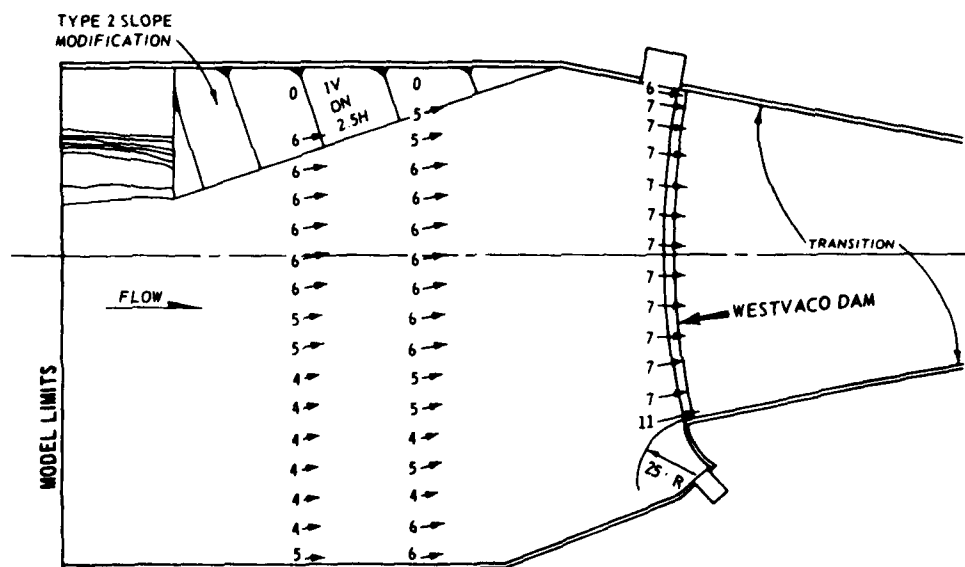
PLAN  
(1 FT ABOVE CHANNEL INVERT)

PLAN  
(7 FT ABOVE CHANNEL INVERT)

MAXIMUM VELOCITIES  
UPSTREAM OF WESTVACO DAM  
TYPE 3 MODIFICATION  
DISCHARGE 13,400CFS
